タコマ橋落橋の謎を解く！

田中 洋

Tacoma Narrows Bridge (1940) 855m

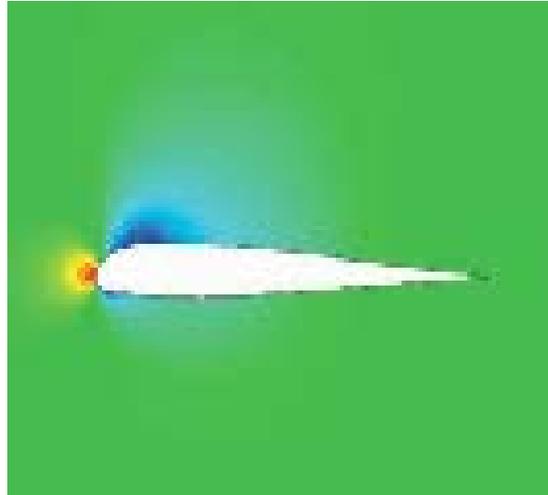
FIG Static Pressure Field on a
NACA Airfoil
(Trailing edge **fulfills Kutta condition**)

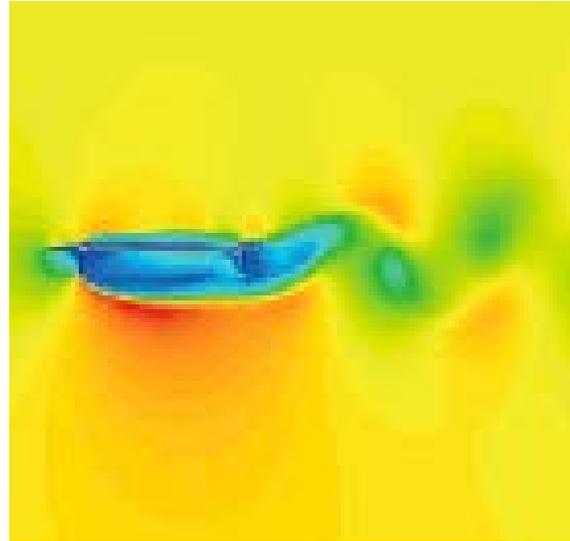
FIG Flow around Bluff Bodies
(trailing edge does **not fulfill Kutta condition**)

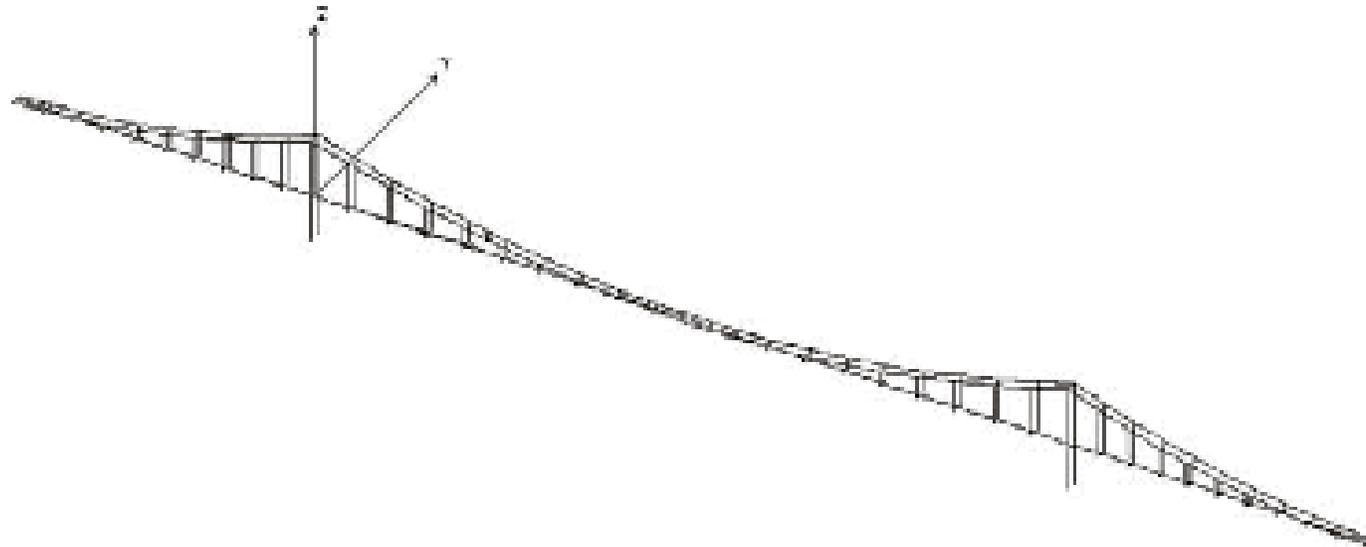
Finite Model of Original Tacoma Bridge

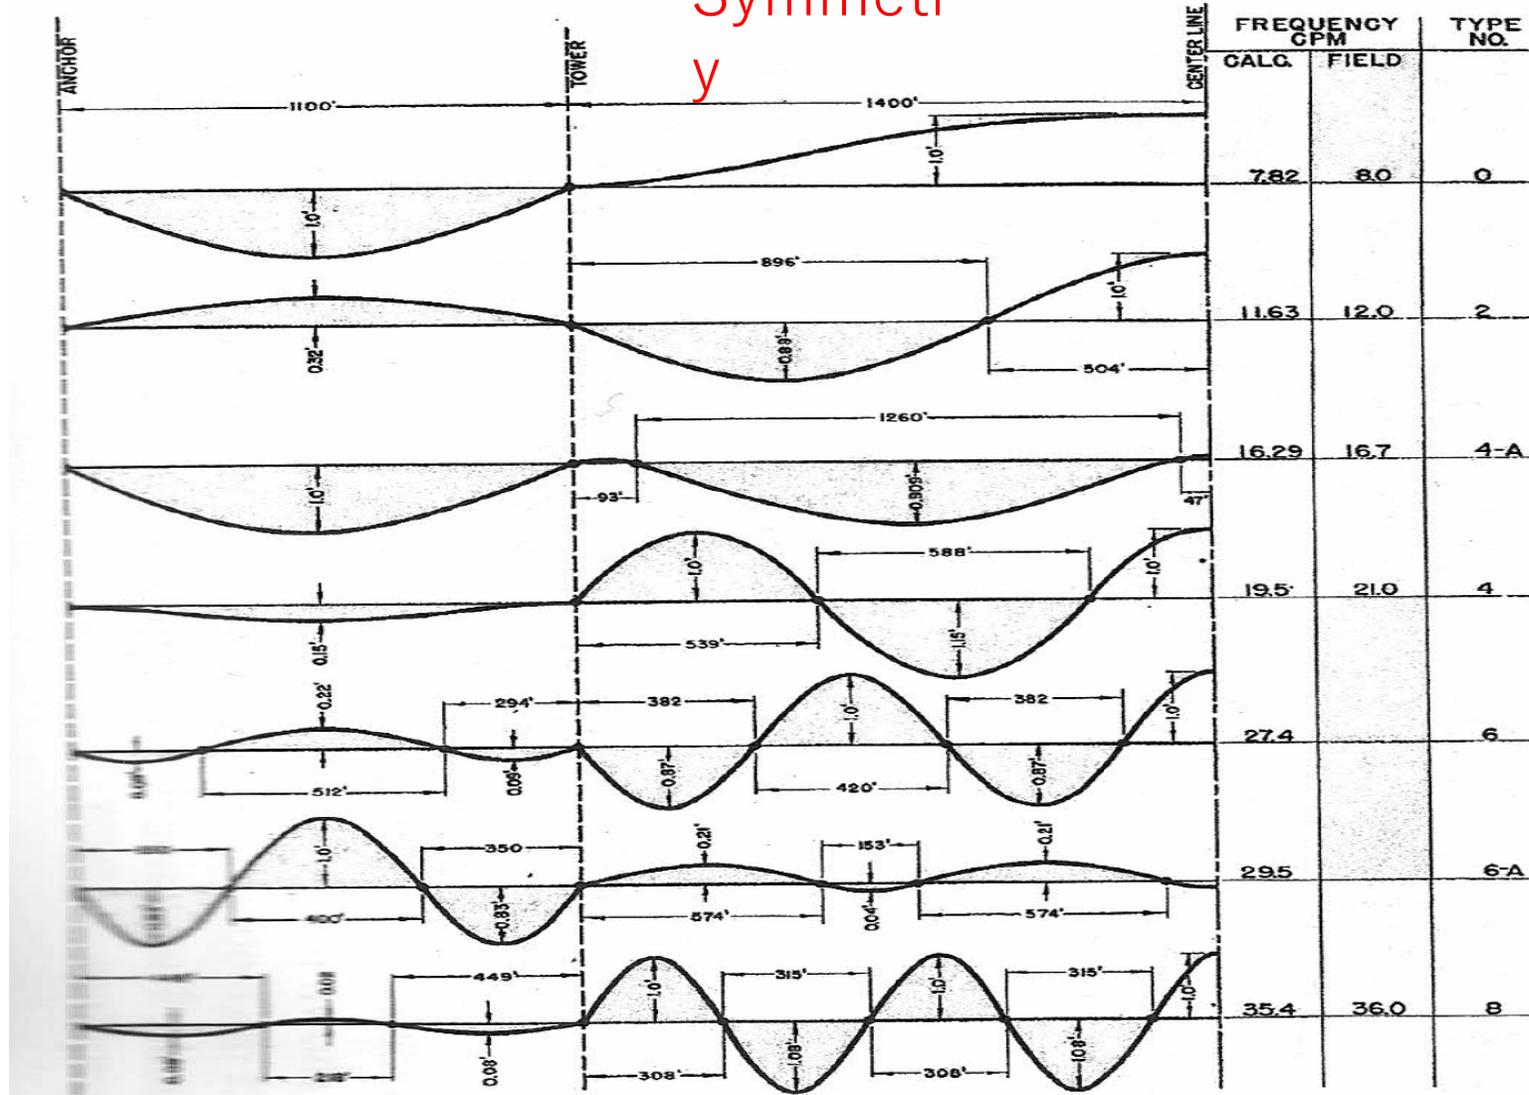
Vibration Modes

Symmetry
y

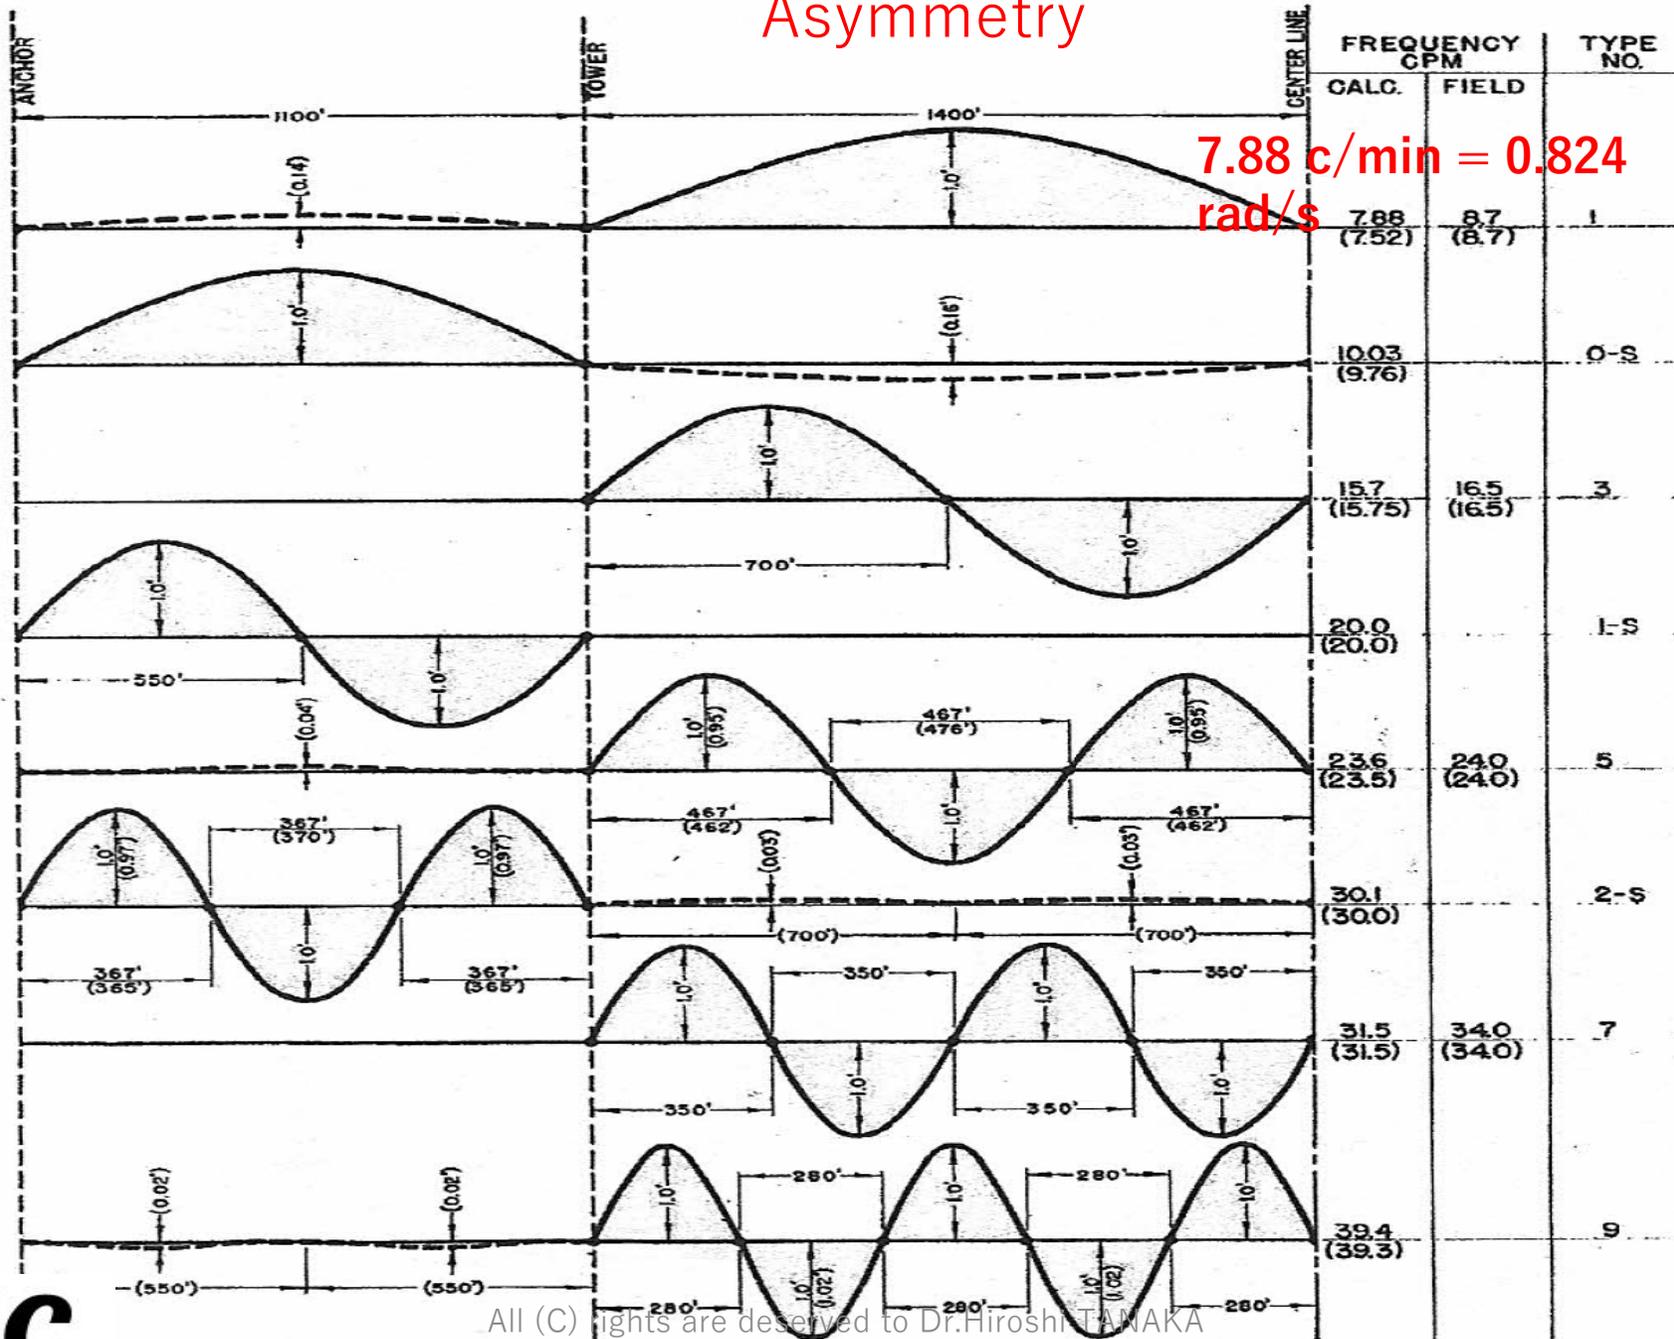
Asymmetry

7.88 c/min = 0.824 rad/s

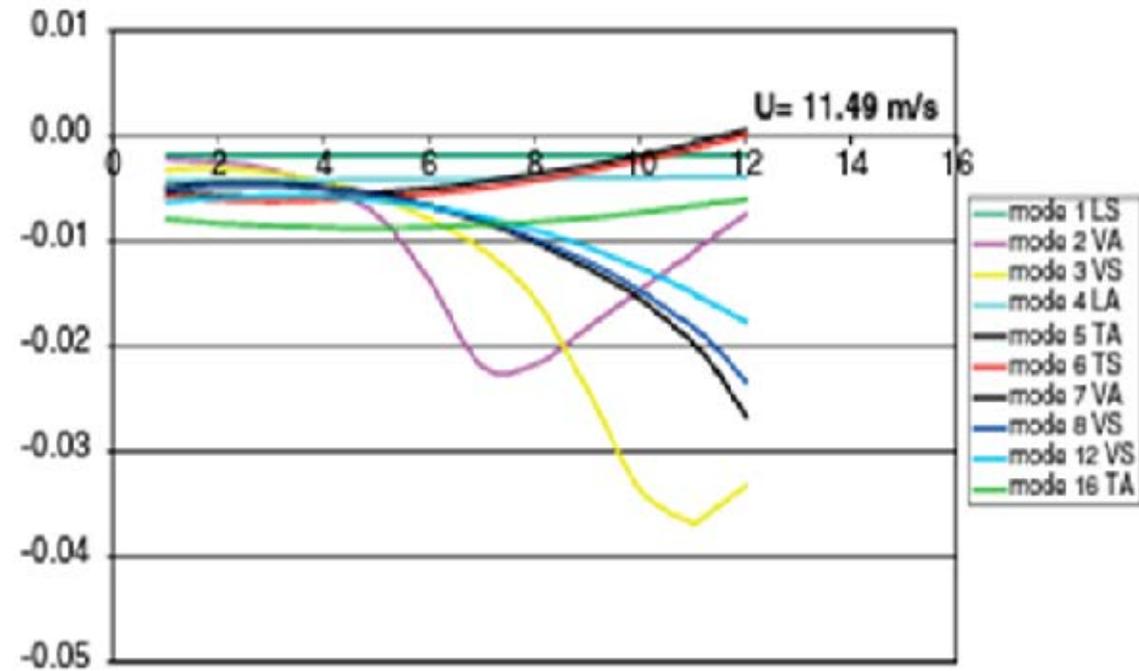
Figure Evolution of α in comparison with U using 10 modes.

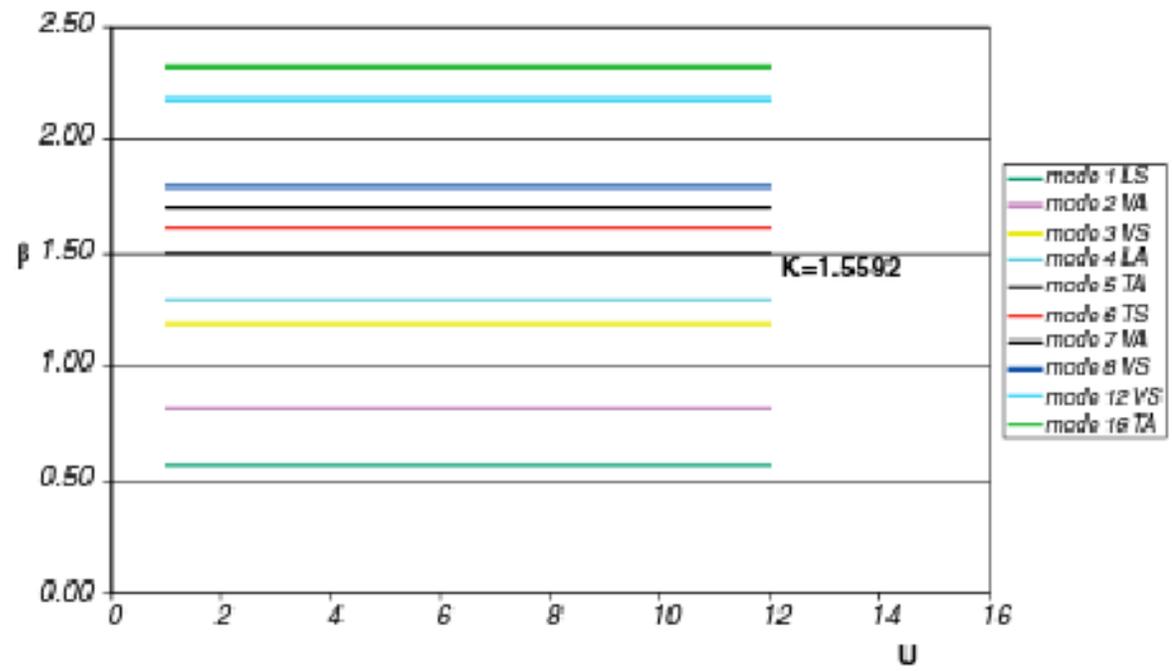
Figure Evolution of β in comparison with U using 10 modes.

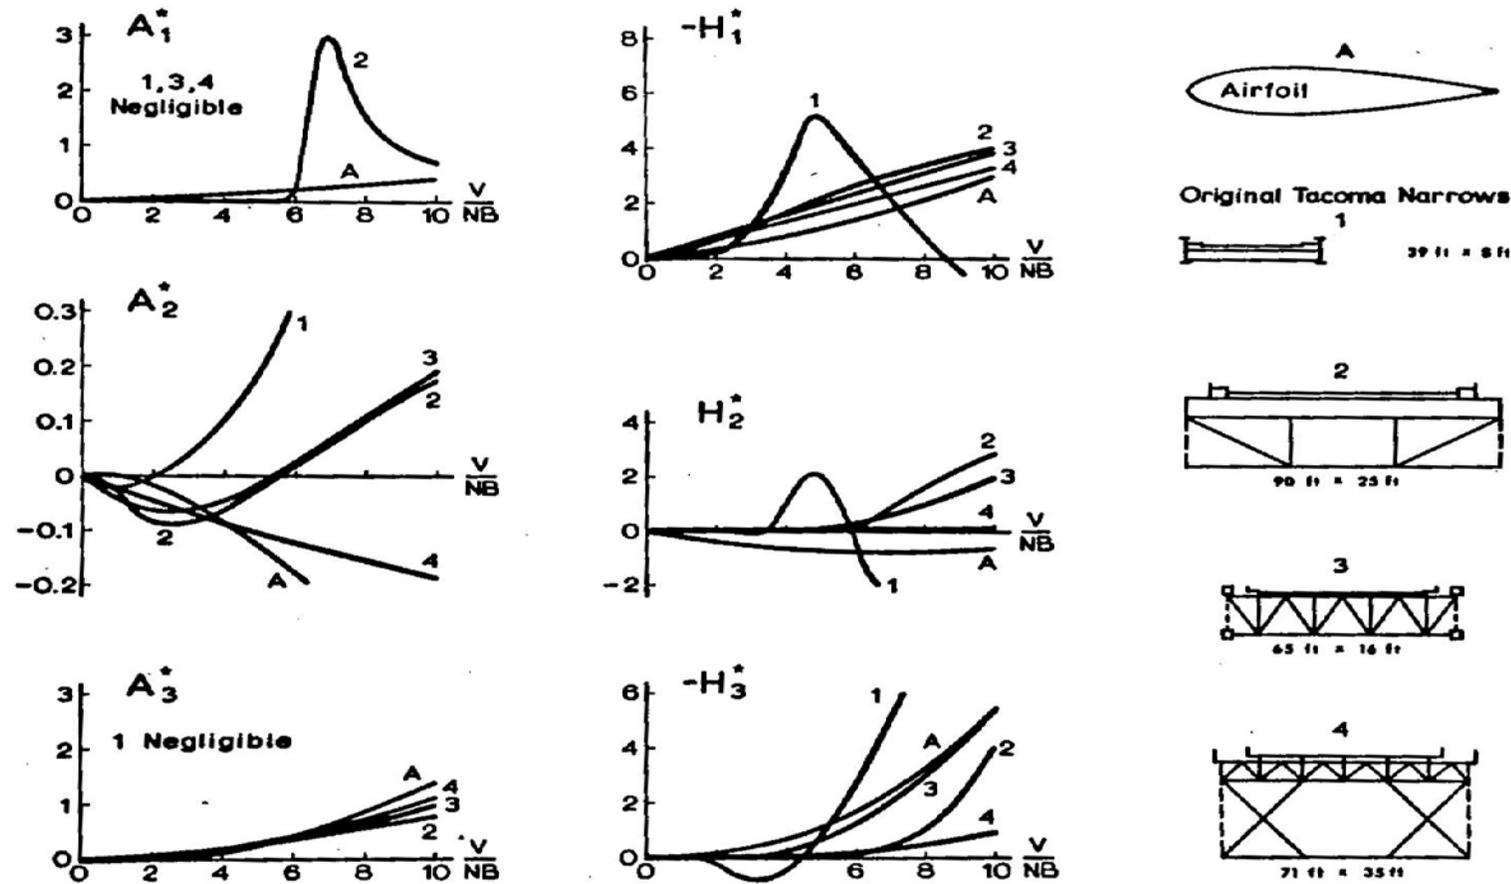
FIGURE 3.2

Flutter derivatives A_2^*

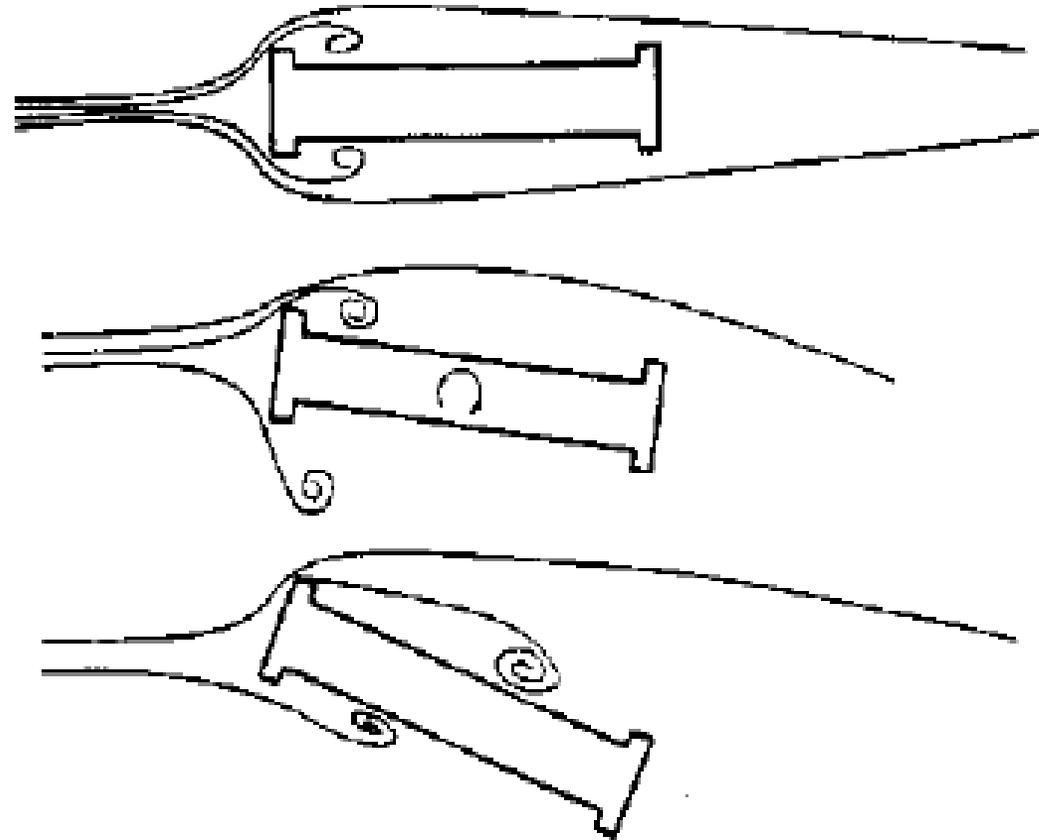
Vortex Pattern over Rotating Deck Section drawn by Scanlan

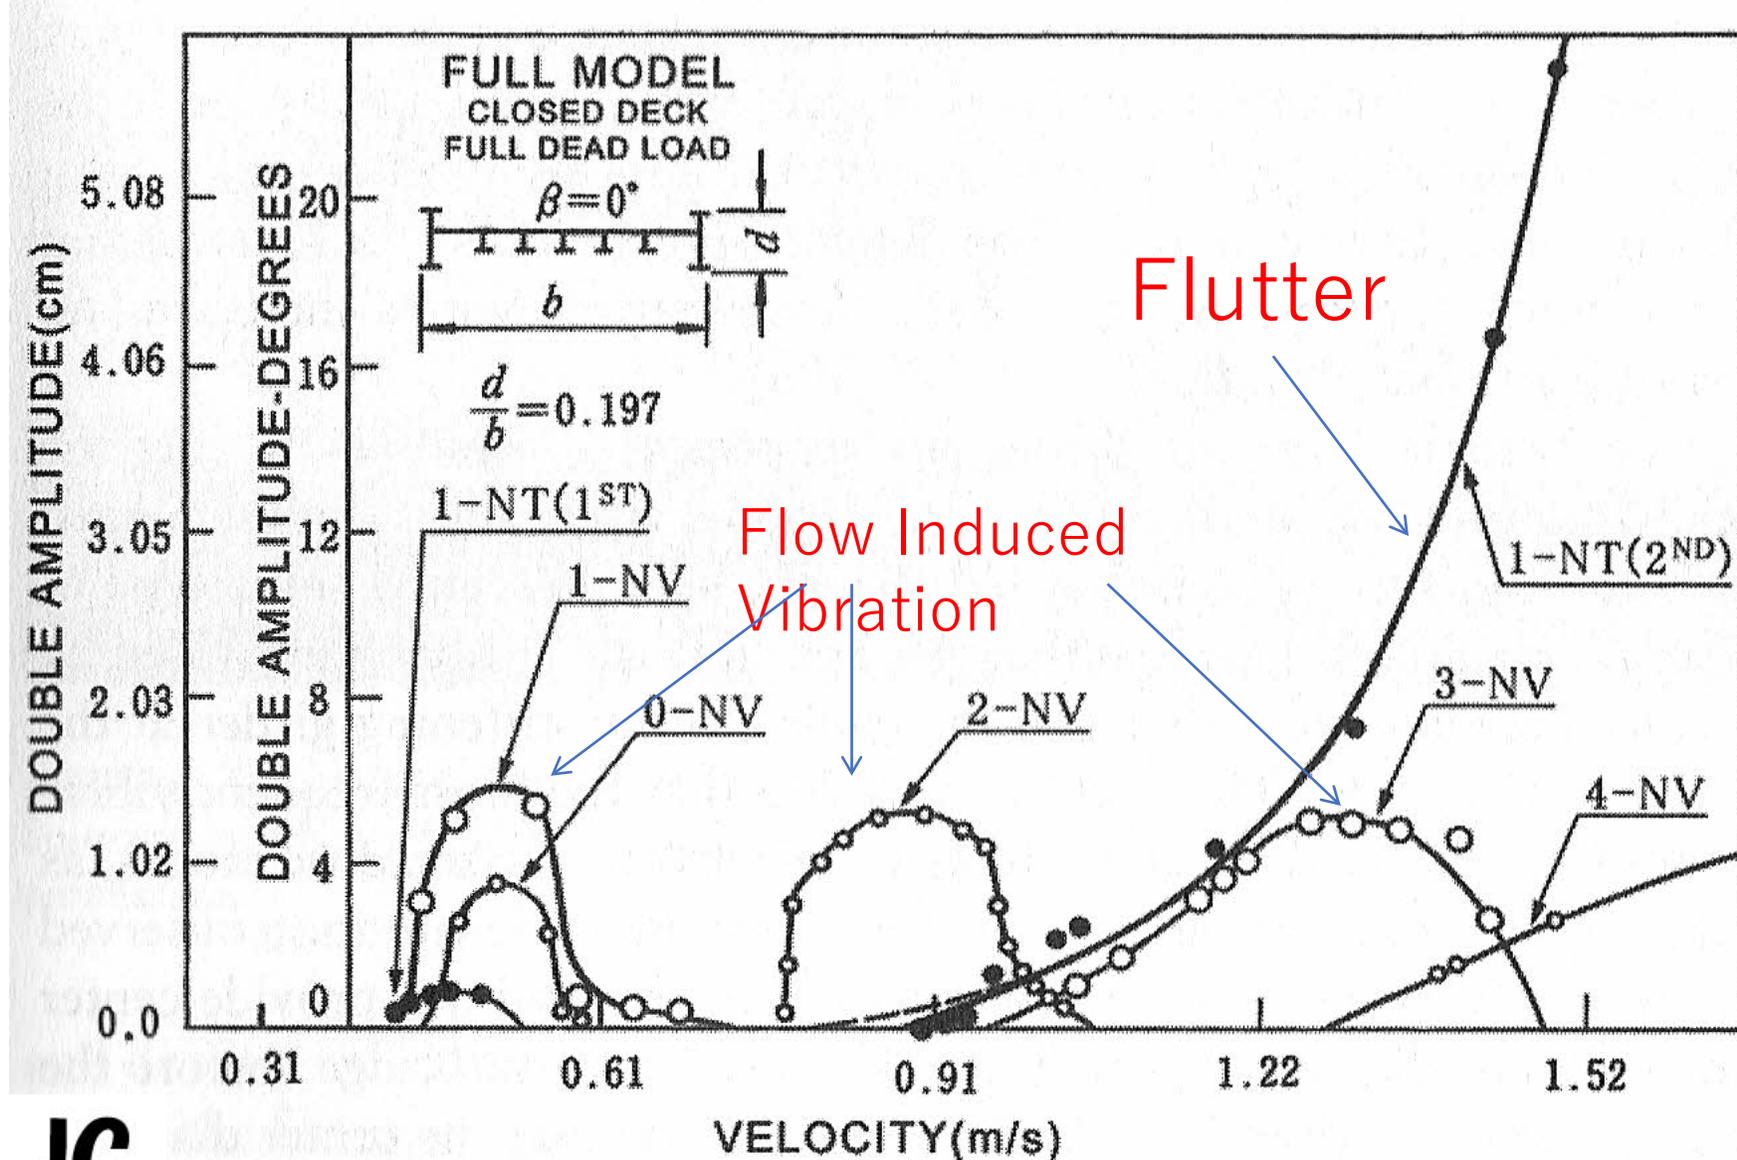
Results of Wind Tunnel Tests of Original Tacoma Bridge

The results of wind tunnel tests

- !-NT(2nd) $U_{cr} = 0.99 \text{ m/s} \times \sqrt{50}$
 $= 7.0 \text{ m/s} \dots\dots$

- $f_{\text{model}} = 1.44 \text{ Hz}$
 $f_{\text{proto-type}} = 1.44 / \sqrt{50}$
 $= 0.20 \text{ Hz} \dots\dots$ **The same value**
of observation

- $2.20 \text{ m/s} \times \sqrt{50} = 15.6 \text{ m/s}$

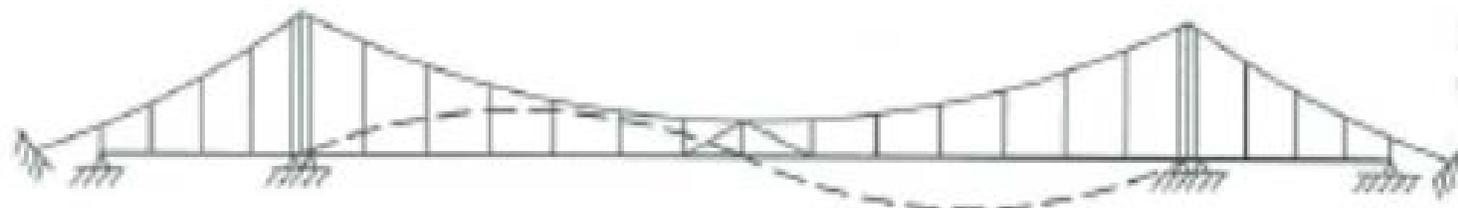
Figure 5-6. Role of the center diagonal stays.
Source: Courtesy of Tadaki Kawada.

- センターダイヤゴナルステイが破断したため、撓みモードから、ねじれモードに変化した。
- 著名な橋梁設計家のスタインマン氏が初めて提唱した意見である。彼の非難の矛先は、彼のライバルのモイセイエフ氏であった。モイセイエフ氏は、タコマ橋の設計者で時めいていた。
- モイセイエフ氏は、この事件後三年で失意でか？早死にした。

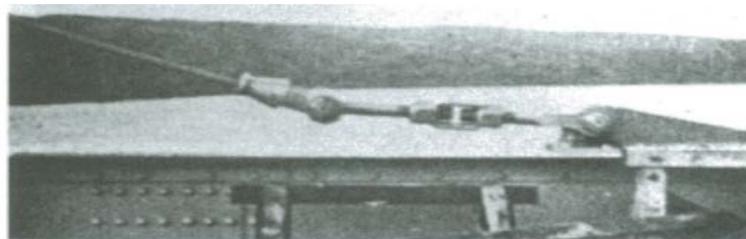
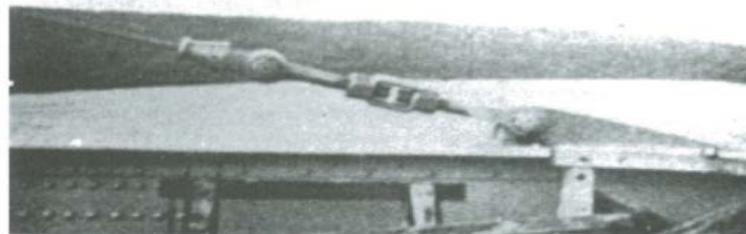
Figure 5-7. Center diagonal stays just before the collapse.
Source: University of Washington Libraries, Special Collections, negative UW26371, with permission.

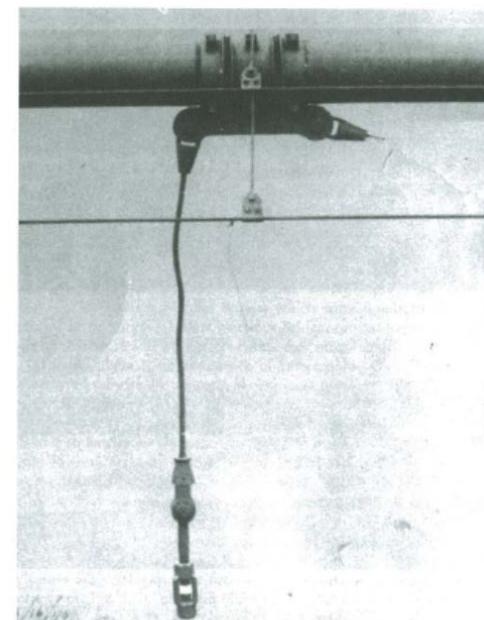
Figure 5-8. Center diagonal stays after the collapse.
Source: University of Washington Libraries, Special Collections, with permission.

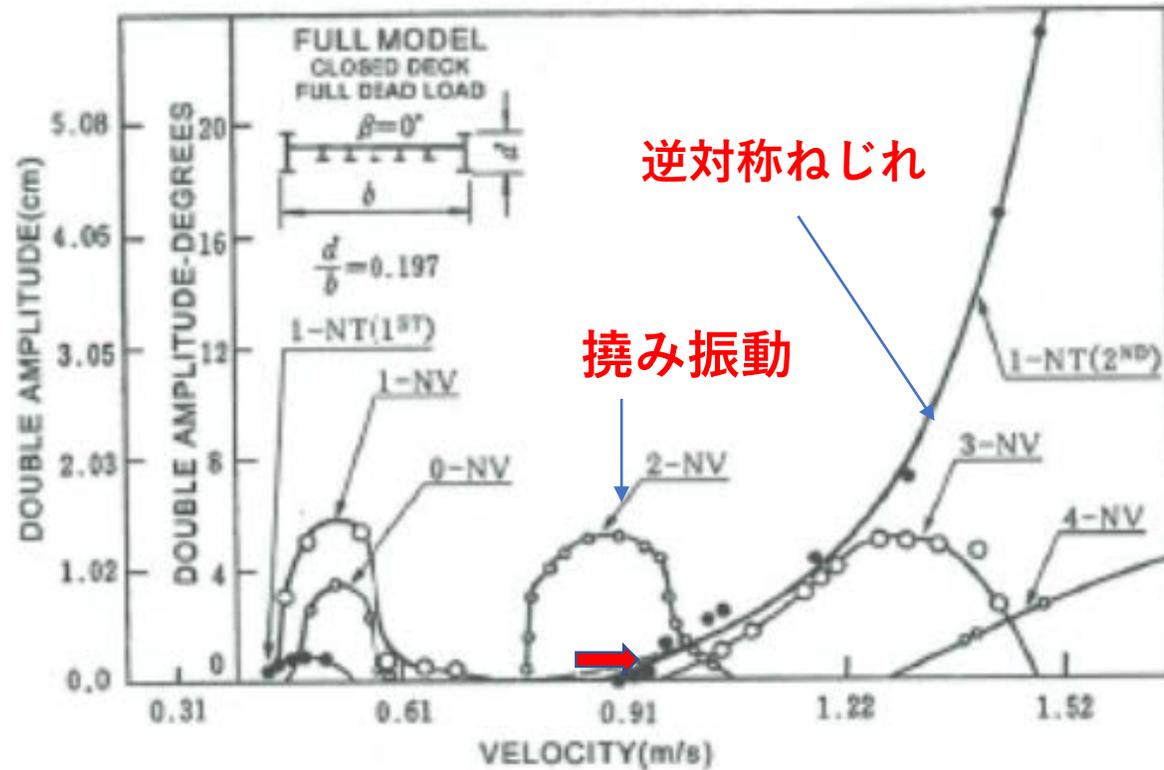
Figure 5-5. Wind speeds vs. vibration in wind tunnel testing of the full-span model. 0-NV, vertical bending vibration with no node; 1-NT, 1-node torsional vibration; 1-NV, 1-node vertical bending vibration; 2-NV, 2-node vertical bending vibration; 3-NV, 3-node vertical bending vibration; 4-NV, 4-node vertical bending vibration.

- 片山技報に詳しいが、風洞試験と整合させると、風速が急に高くなったと推察した。このため、フラッターと渦励振の異なる空力現象が干渉するという複雑な空力現象が生じたかもしれない（片山技報参照）と興味ある空力振動論を展開している。
- ただし、現場の風速計については、不調であったため正確な風速記録に確信が持てないことが原因追及を困難にしているとしている。
- 残念ながら、正しい風速計は、現場からかなり離れていたため論拠とできなくなったことから、本橋落橋の謎追及を困難にしているようだ。

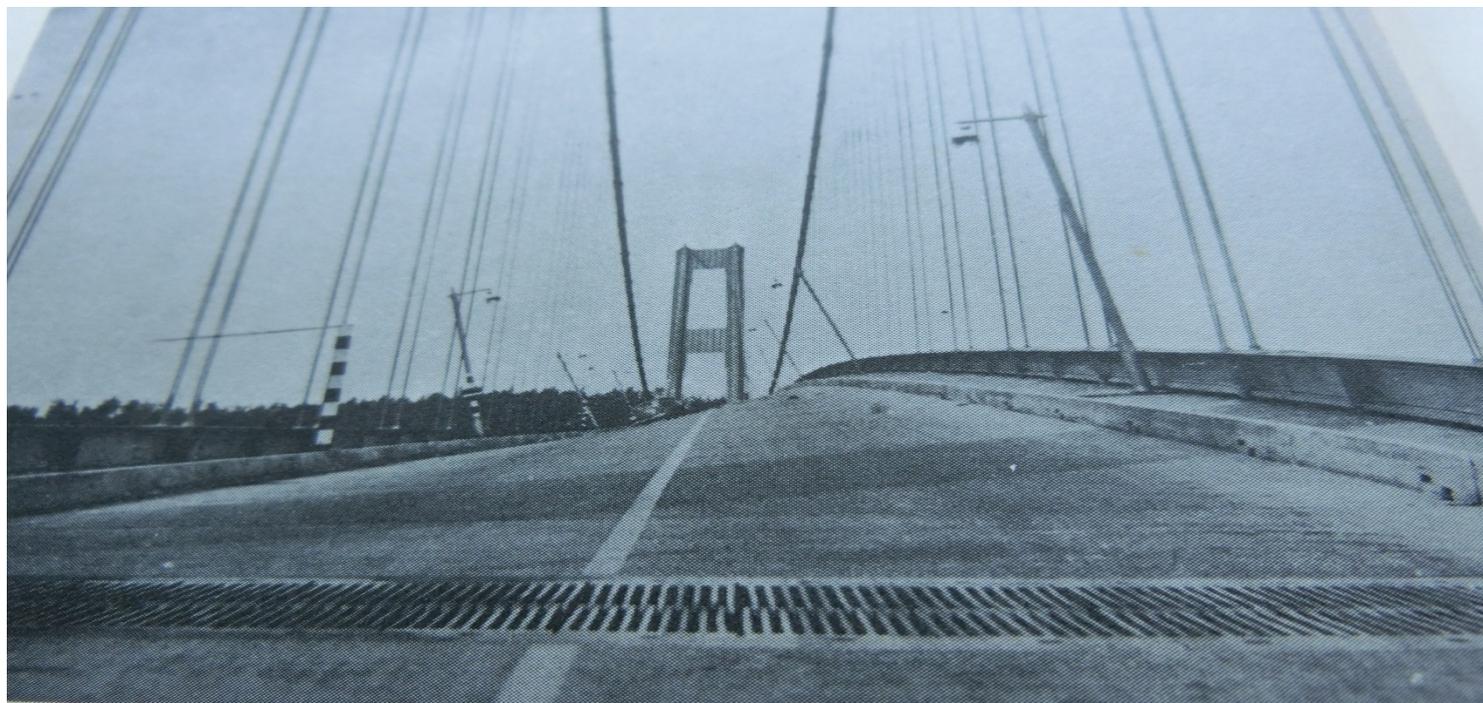
PHOTO :
Y.C.FUNG/AEROELASTICITY

伸縮装置が壊れている! →

$C \cdot L$ ($C = Hw/EI$)が、
5以上なら、最低モードは、ね
じれ1次 (伊藤学：鋼橋Ⅲ) タコ
マ橋は、13.4である。

- 約2時間半の撓み振動において、中央径間と側径間が調和振動していたが、次第に構造疲労（例えば、伸縮装置がかみ合わなくなったり、側径間のケーブルバンドに滑りが生じたり）して、**映画に見られるように、中央径間と側径間がバラバラなモードに変化し、機能的には単径間吊り橋に変化してしまった。**
- 東大名誉教授の伊藤学氏の著書である鋼橋III（P.428）によれば、**スパンの長い単径間吊橋では、映画に見られるスパン中央に節点を有する逆対称型固有振動が最低の振動数を与える**と主張している。 Messina 海峡大橋も同様に逆対称固有振動が最低振動数である。
